CENTRAL INTELLIGENCE AGENCY

OUNTRY East Cermany		REPORT		25
JBJECT Reconstruction at	Stendal Airfield	DATE DISTR.	12 SEP 1867	
		NO. PAGES	1	
		REQUIREMENT NO.	RD	
ATE OF		REFERENCES		
IFO.		PRO	CESSING COPY	25
ACE &		•	CESSING COF!	20
ATE ACQ.	ATIONS ARE DEFINITIVE. AF			
on reconstruction under the followin (3) Hard Stendings and (6) Surface (6)	at Stendal airfield. ag headings: (1) Run a, (4) Power Cables, nstruction. A sketcl	The report give way Details, (2) (5) New Fuel Instance to showing the fe	report es information Taxiway Details, tallation.	
on reconstruction under the following (3) Hard Stendings and (6) Surface Co	at Stendal airfield. ng neadings: (1) Run s. (4) Power Cables.	The report give way Details, (2) (5) New Fuel Instance to showing the fe	report es information Taxiway Details, tallation.	
on reconstruction under the followin (3) Hard Stendings and (6) Surface Co	at Stendal airfield. ag headings: (1) Run a, (4) Power Cables, nstruction. A sketcl	The report give way Details, (2) (5) New Fuel Instance to showing the fe	report es information Taxiway Details, tallation.	_ 25

SECRET 25X1 25X1 AIR/MILITARY STENDAL airfield - Reconstruction 25X1 Aprendix: Attached as

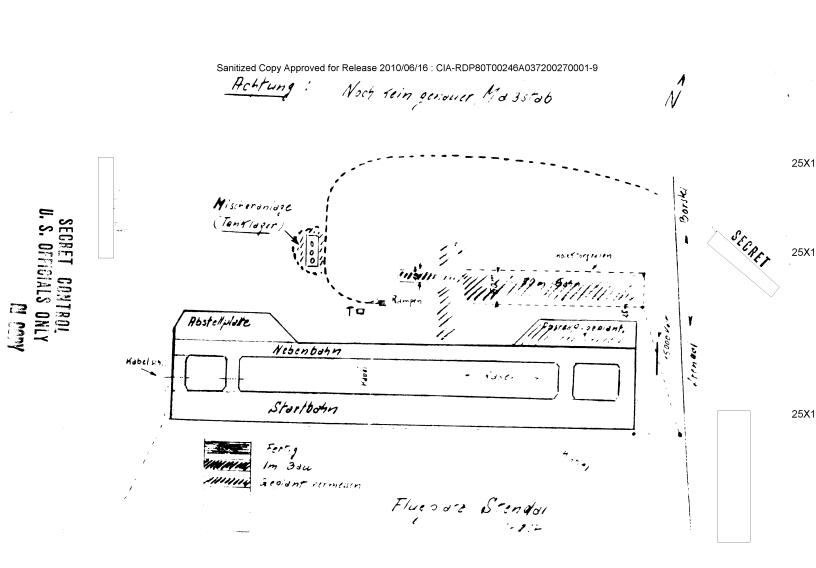
(possible hardstanding) area adjoining the eastern end of the	OEV.4
	parallel taxiway.	25 X 1
	The storm water from this hardstanding is to be fed away into the	
	common soak-away adjoining the SE corner of the runway (for approximate position see sketch attached).	
	Construction of this main hardstanding and associated taxidays is	
	about to commence and the guide rails for the concrete-laying	
	machines have been laid.	
	POWER CABLES	
)	Two pipelines, each having a diameter of approximately 10 cms.,
